# Images in medicine

## Metal in Mandible

**Pan African Medical Journal. 2016; 23:192 doi:10.11604/pamj.2016.23.192.9425**

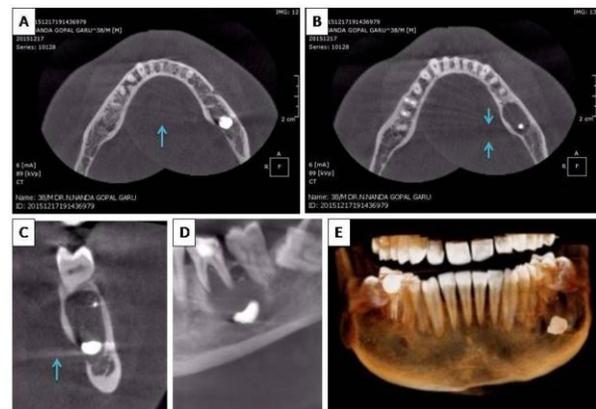
A 38 year old male patient presented to a radiology center for cone beam computed tomography (CBCT) and the working maxillofacial radiologist spotted a very peculiar finding - There was a large piece of metal in the mandible (size 0.5 cm X 0.5 cm). Here in we have provided a commentary on CBCT artifacts seen in this case along with a short explanation on the source of metal. Based on our observation the object in the mandible is certainly a metallic filling (See figure). This finding is based on the artifacts (acquisition artifacts) that were produced around the suspected material. Two types of artifacts were seen: 1. Scatter and 2. Beam hardening artifacts. Scatter occurs due to the diffraction of original beam after interaction with material. Scatter causes streak artifacts in the reconstruction (Blue arrows in panel A and C). Beam hardening artifacts were also found; they are more common. The lower energy rays suffer significant absorption when passing through the object. Higher the density and atomic number (metals) greater is the absorption. In the reconstruction image they are seen as darks streaks (Between blue arrows in panel B). Materials that often cause beam hardening include metallic restorations and titanium implants. Yes, even light metals such as titanium cause massive beam hardening and amalgam which is the material suspected in this case causes even greater hardening of beam. We strongly think that the metal must be amalgam. Some metal must have got displaced

during the stage of condensation of filling in the tooth (most likely 36) just above the large radiolucent lesion. This is the most probable explanation. Unfortunately, this patient couldn't be followed up and the source of metal is still unknown leading to many speculations.

**Figure 1:** Blue arrows pointing scatter and beam hardening artifacts casted by a large metallic object in mandible (0.5x 0.5 cm)
