## Case report

# Conservative esthetic management of post orthodontic treatment discolored tooth with calcified canal: a case report

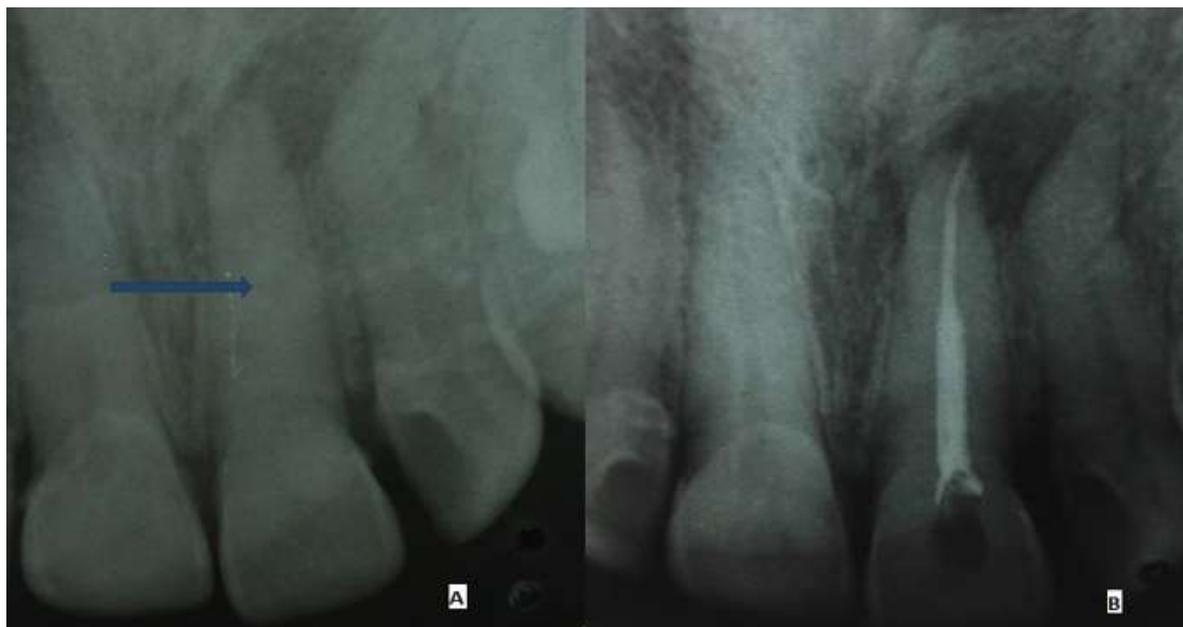
**Figure 1:** periapical radiographs of maxillary right central incisor: A) preoperative: calcified canal (blue arrow); B) obturation

A 23 year old female patient presented with the chief complaint of discolored maxillary right central incisor. Patient gave the history of malaligned maxillary right central incisor and subsequent orthodontic treatment that was finished two years ago. The response to vitality tests was negative. On percussion and palpation test, patient reported mild pain. Digital periapical radiograph revealed right maxillary central incisor with obliterated canal and diffuse periapical radiolucency (Figure 1A). The tooth had yellowish grey crown. Periodontal pocket depth was normal. A diagnosis of pulp necrosis and calcific metamorphosis was reached. After giving anesthesia and isolation, an endodontic access cavity was prepared at upper right central incisor with number 2 round diamond bur (Mani, Inc. Japan). The slit of the pulp chamber became visible and calcification was removed by using ultrasonic tip. Canal orifice was located with the help of endodontic explorer (DG-17). Patency of the canal was achieved with 08 K-hand file (Mani, Inc. Japan). The working length was measured with the radiographic method. After preparation of glide path canal was cleaned and shaped to size 30/.04 by using hyflex© CM file system (coltene). Irrigation was done by utilizing 3% sodium hypochlorite (septodont) and EDTA 15% (septodont), alternatively, with rinse of saline in between. The 27 gauge closed end side vent needle was used for irrigation. The canal was dried with sterile paper points. Obturation was done with Gutta Percha (GP) points and calcium hydroxide based sealer (sealapex, sybron endo) by using cold lateral condensation technique (Figure 1B).

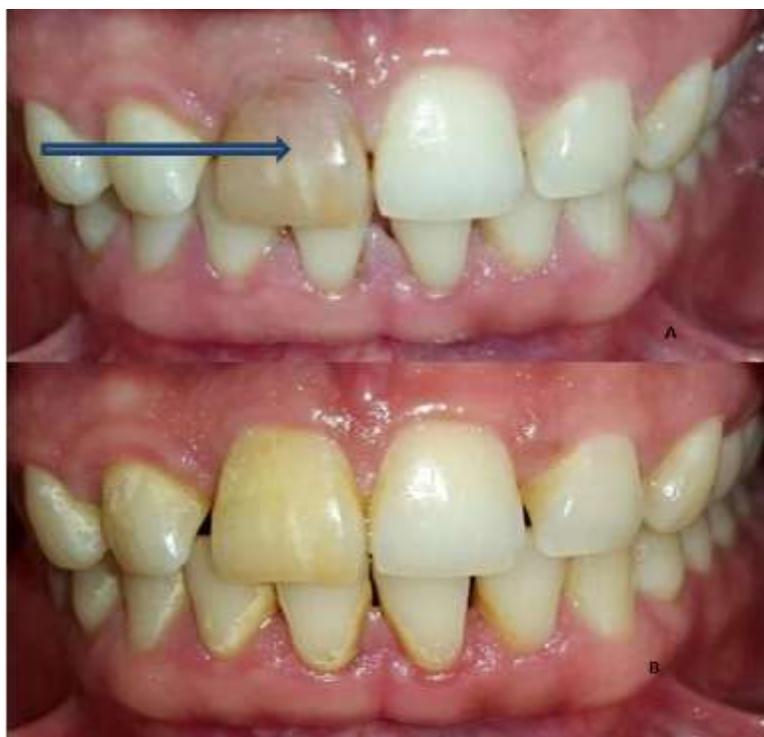
**Figure 2:** A) preoperative picture with discolored tooth (blue arrow); B) postoperative picture

Subsequently, GP was removed 2-3mm apical to canal orifice and restorative glass ionomer cement (GIC) was applied on the obturating material to minimize leakage of bleaching agent. After placing rubber dam 35% hydrogen peroxide (opaescence® endo® ultradent gel) was injected into the chamber for the management of yellowish grey

crown (Figure 2A), followed by the placement of cotton pellet and sealing of access cavity with restorative GIC (vitremer, 3M). The process was repeated three times after the interval of five days. Desired results were achieved after the third visit and patient was satisfied (Figure 2B). Subsequently, the tooth was permanently restored with resin composite after 7 to 10 days.
